# Contaminated Land Additional Information on the state of Remediation for Proposed Residential Caravan Site at, Thames Street, Newton-with-Scales, Preston, PR4 3RH.

Isaac McDonough  
C/O  
Thames Street  
Newton-with-Scales,  
Preston,  
PR4 3RH.

August 2019

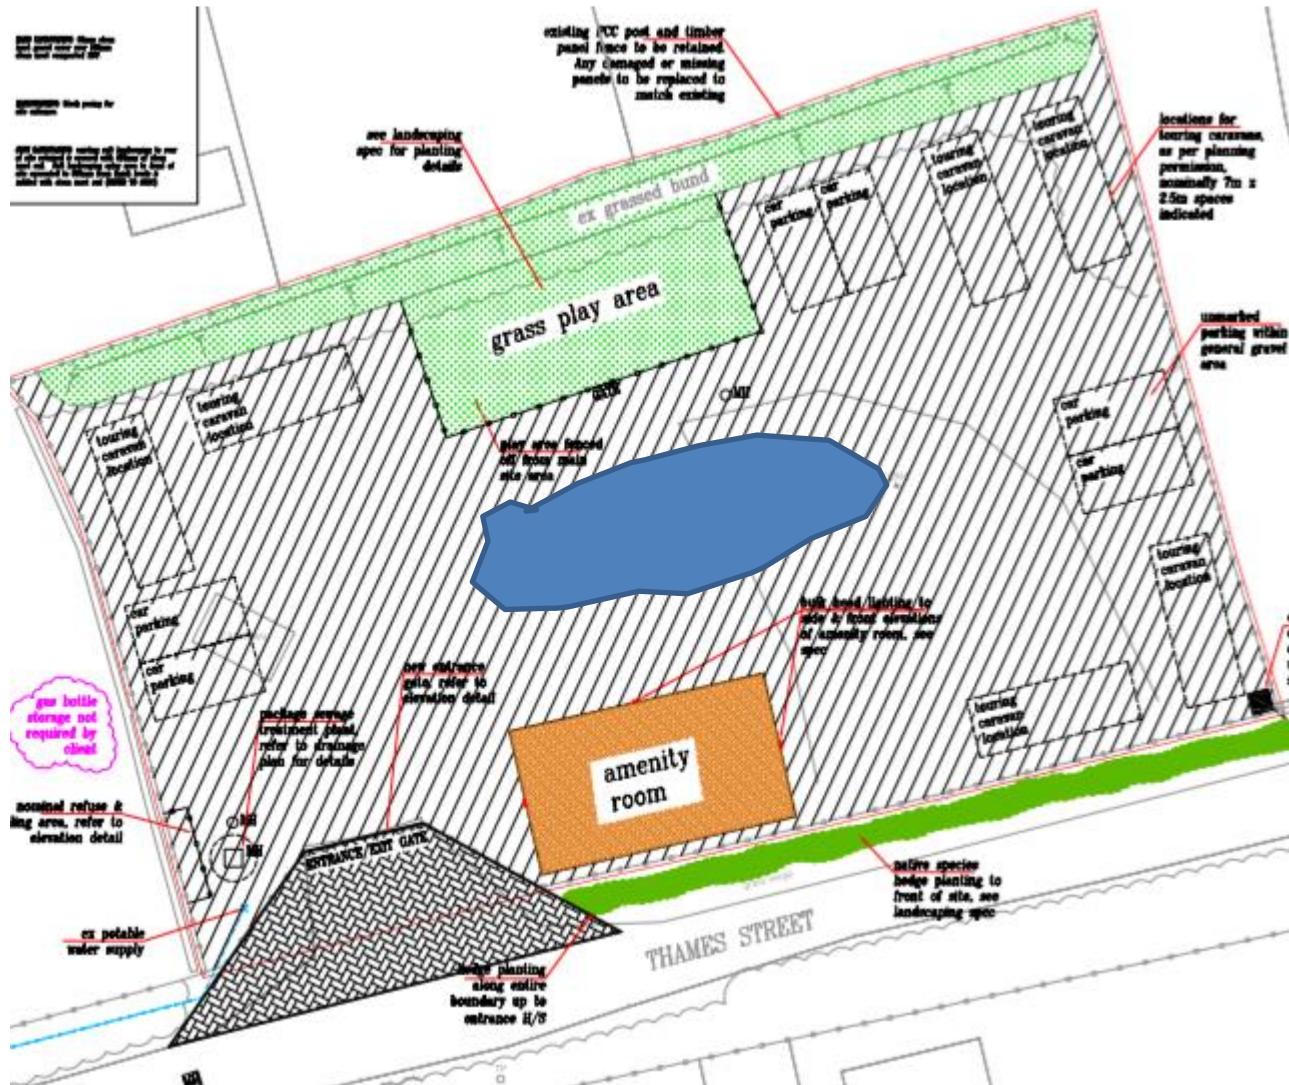
## Figure 1 – Sampling locations

Figure 1 contains a plan of the site with the area in which the asbestos was buried marked. This is under the proposed road way on site.

- 4) Asbestos material was buried at depth ~ 5ft with a 2ft cover (excavated material). This is located in the centre of the site and will be covered by the roadway. The area was chosen by the applicant as it will not be disturbed during the construction of the amenity room.
